To VENTILATE or SEAL A SEATTLE FLAT ROOF ???

Kings County Housing Authority

- Developing Successful Building Retrofit Design for Low Slopped Roof in Seattle

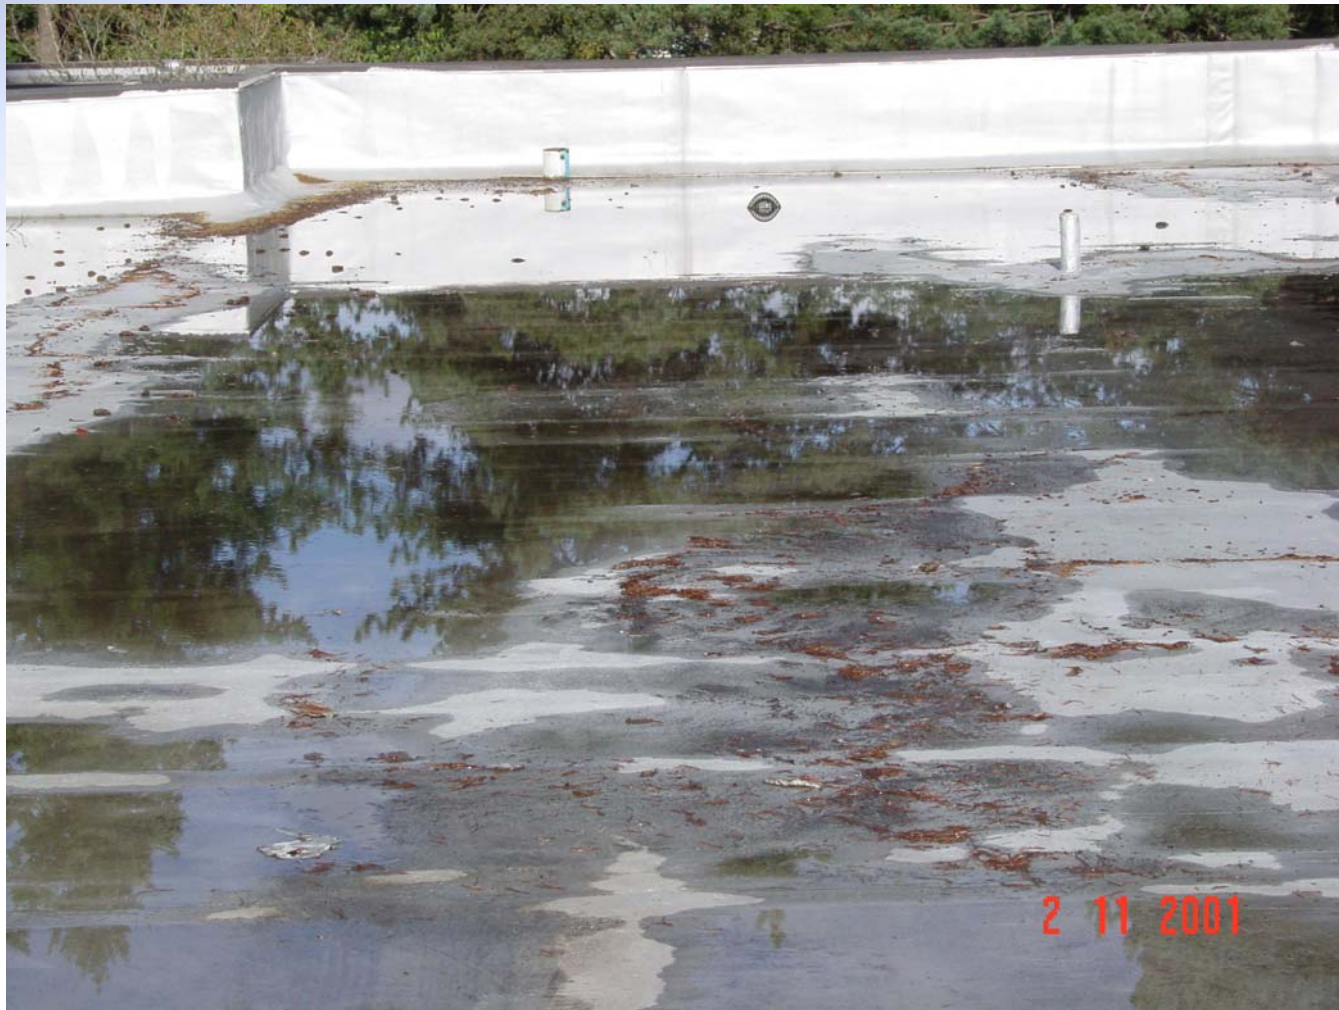
Commonly Found in Seattle and **Everywhere**

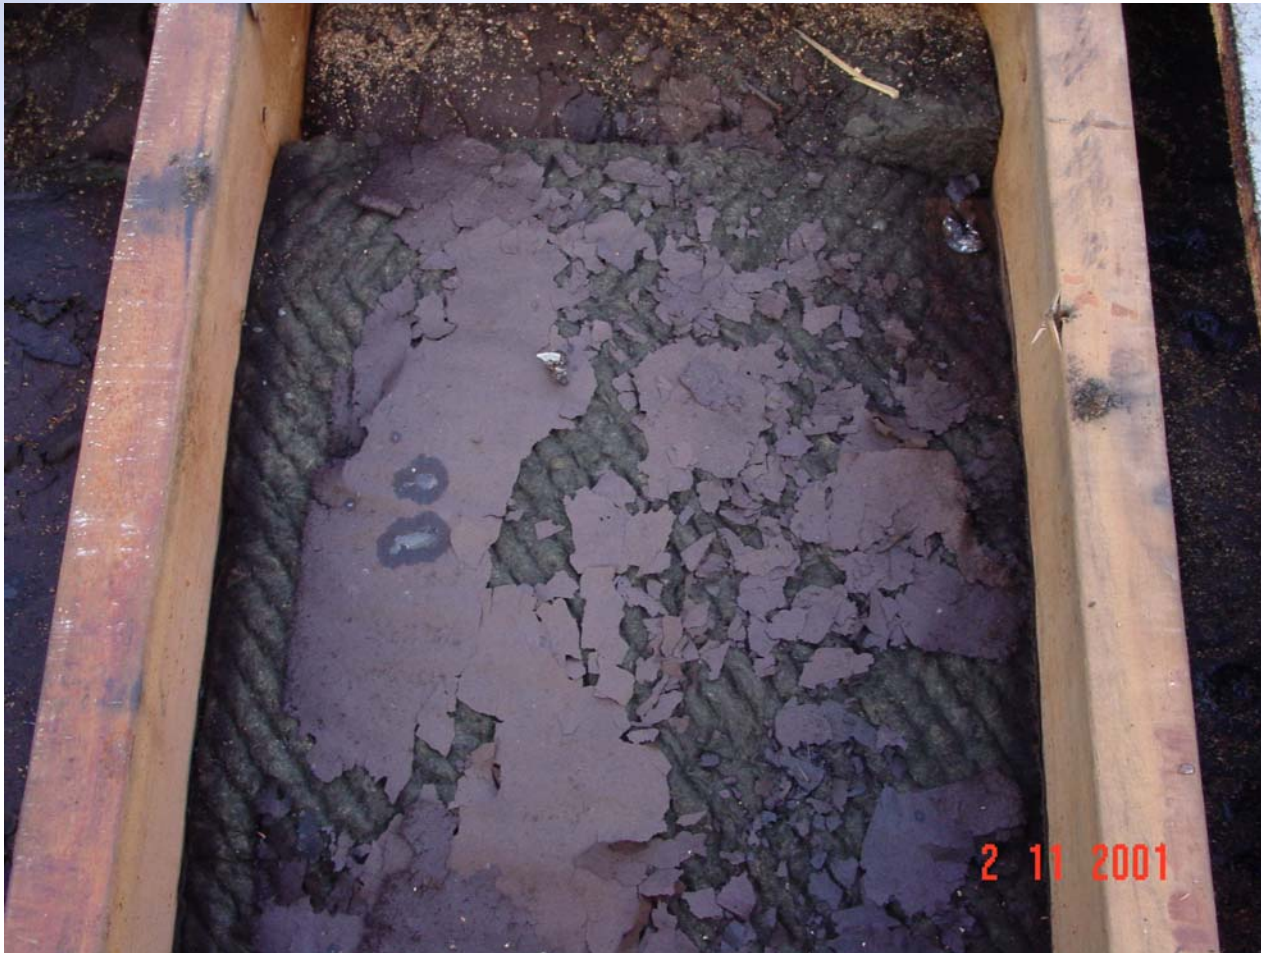
20 years in Service

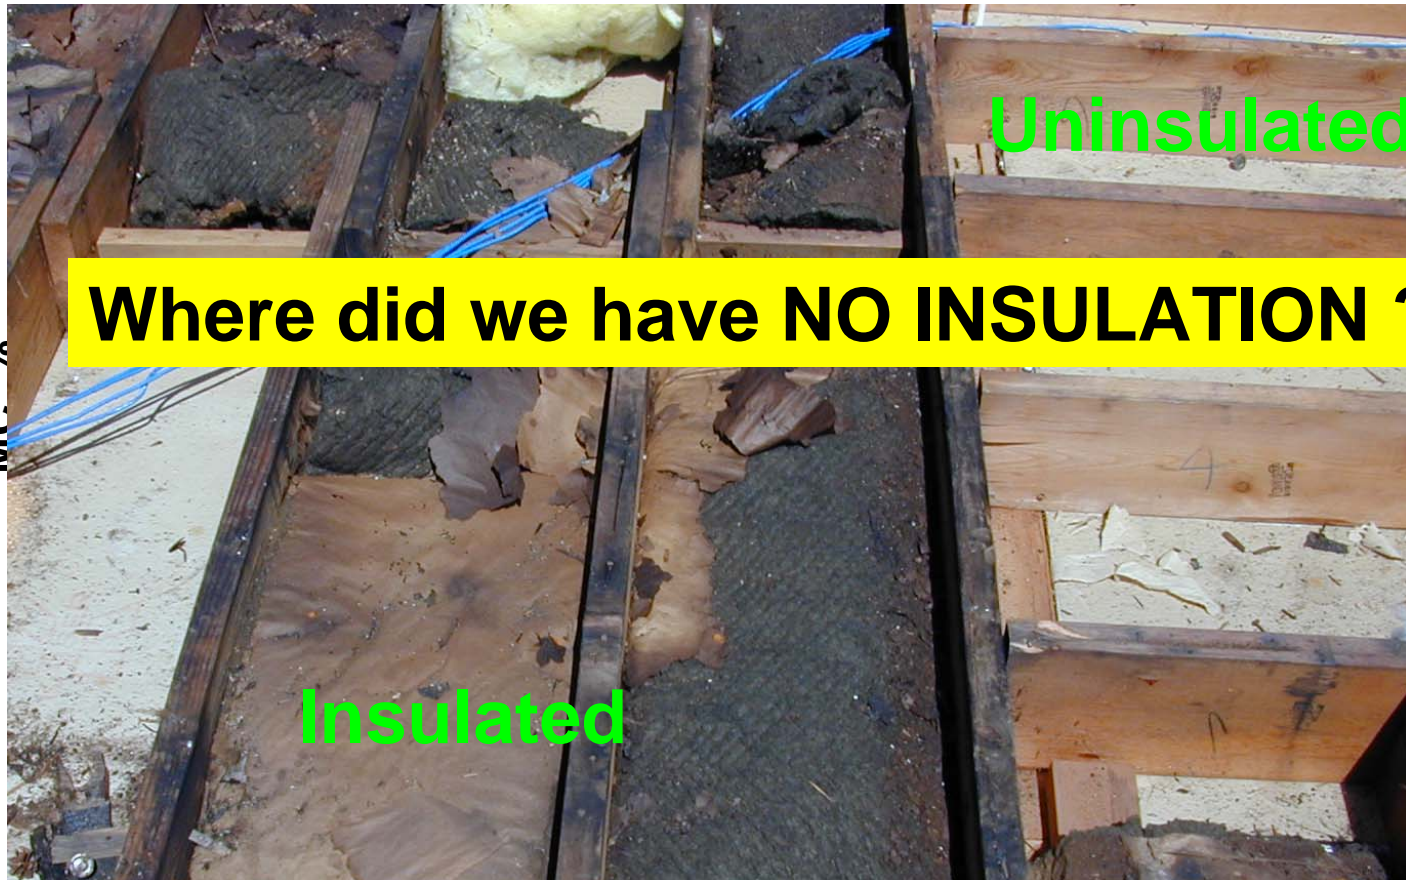
Existing Roof System

Where did we have NO INSULATION ????

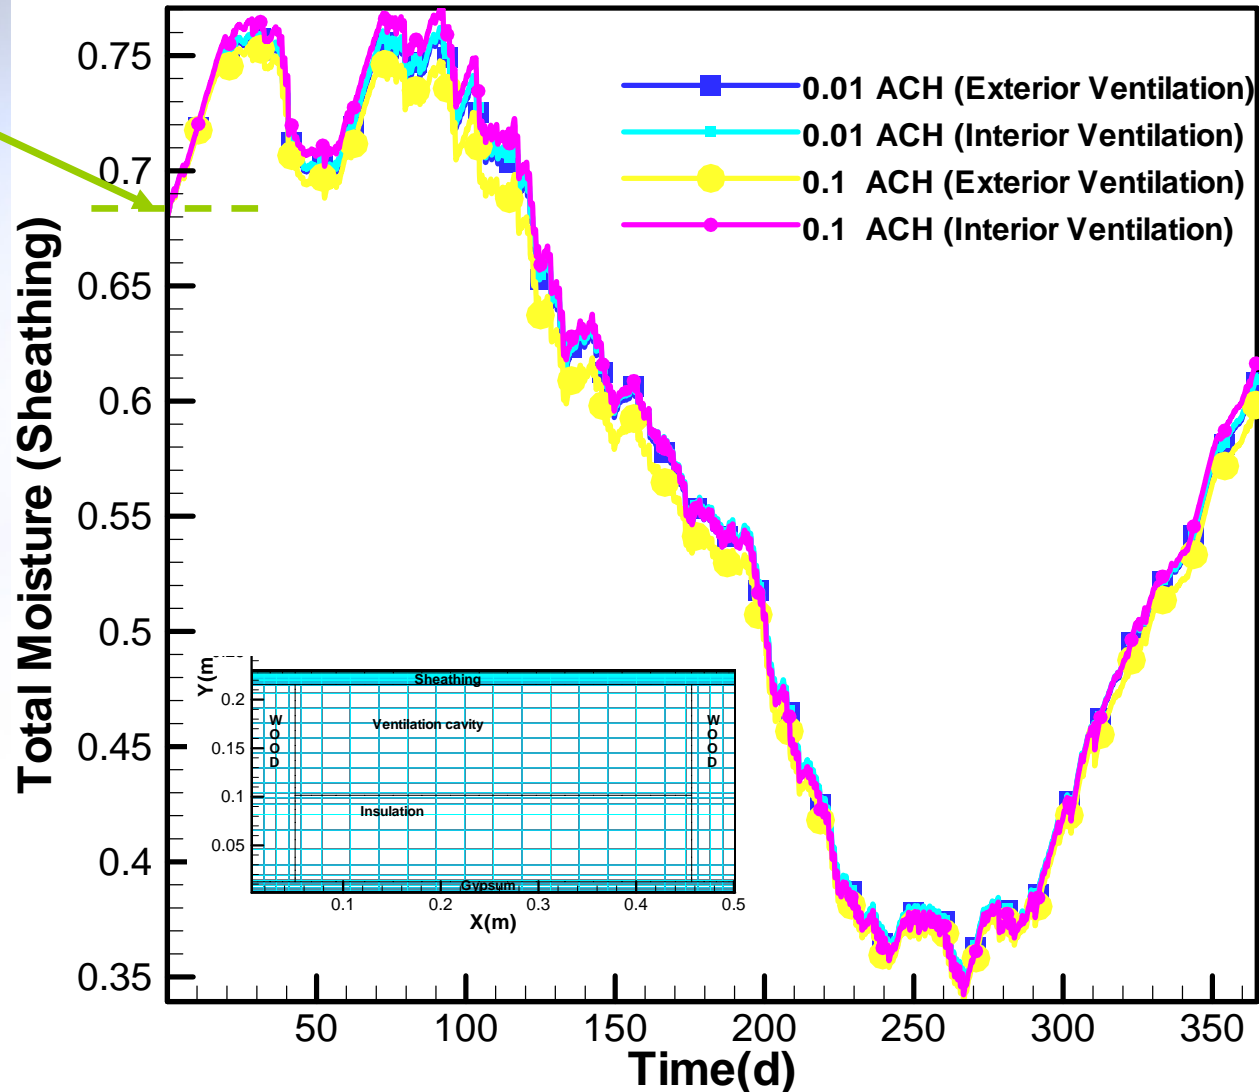
Figure 6: Performance of Existing Roof Sheathing as a function of low interior or exterior ventilation (0.001 and 0.1 ACH)

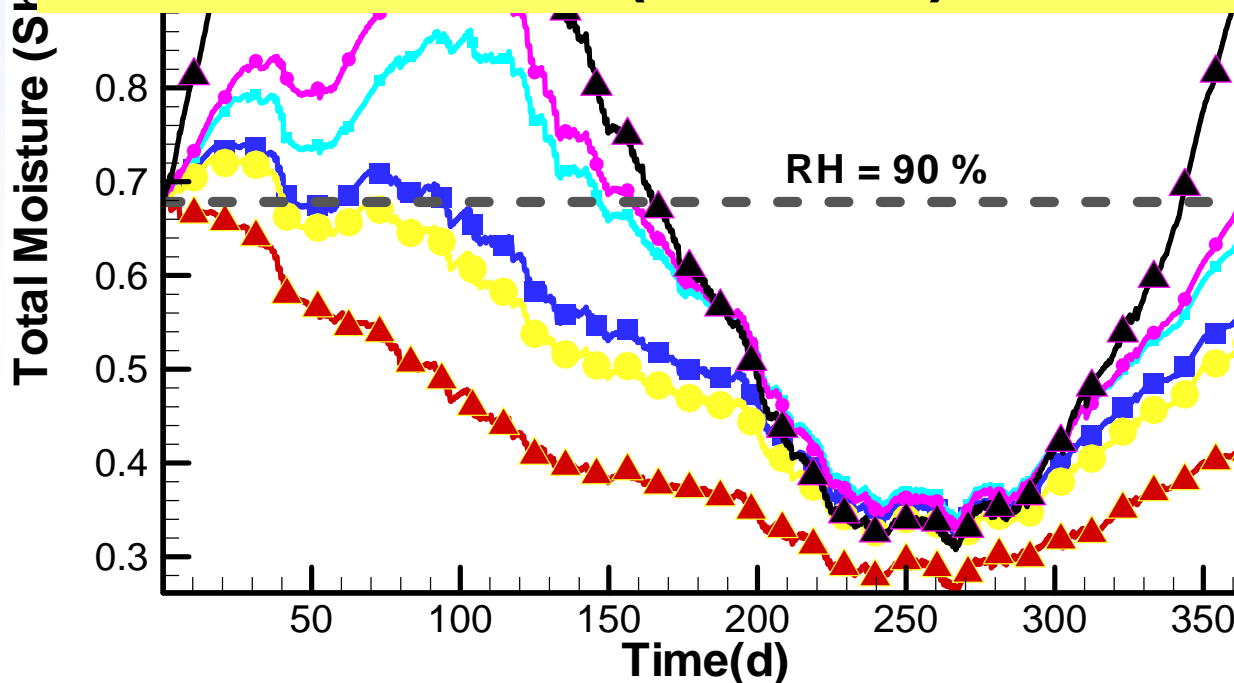
Either Ventilate (Exterior) a LOT or PROBLEMS

Figure 7: Performance of Existing Roof Sheathing as a function of interior or exterior ventilation (0.5, 1, 5.0)

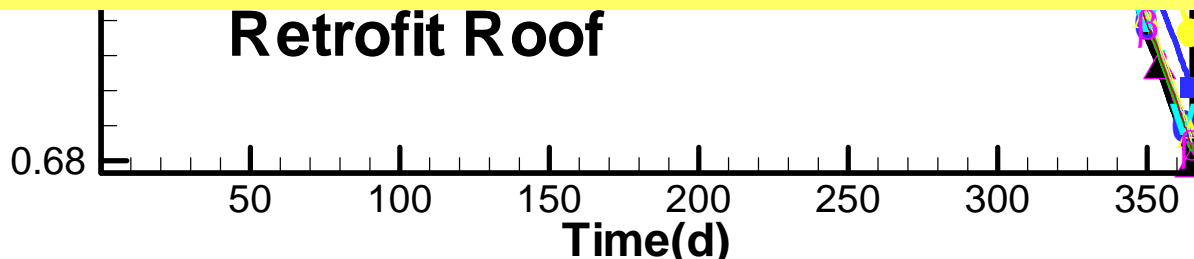
Figure 13: Performance of Retrofit Roof Sheathing as a function of interior or exterior ventilation 0.5, 1.0 and 5.0 ACH)

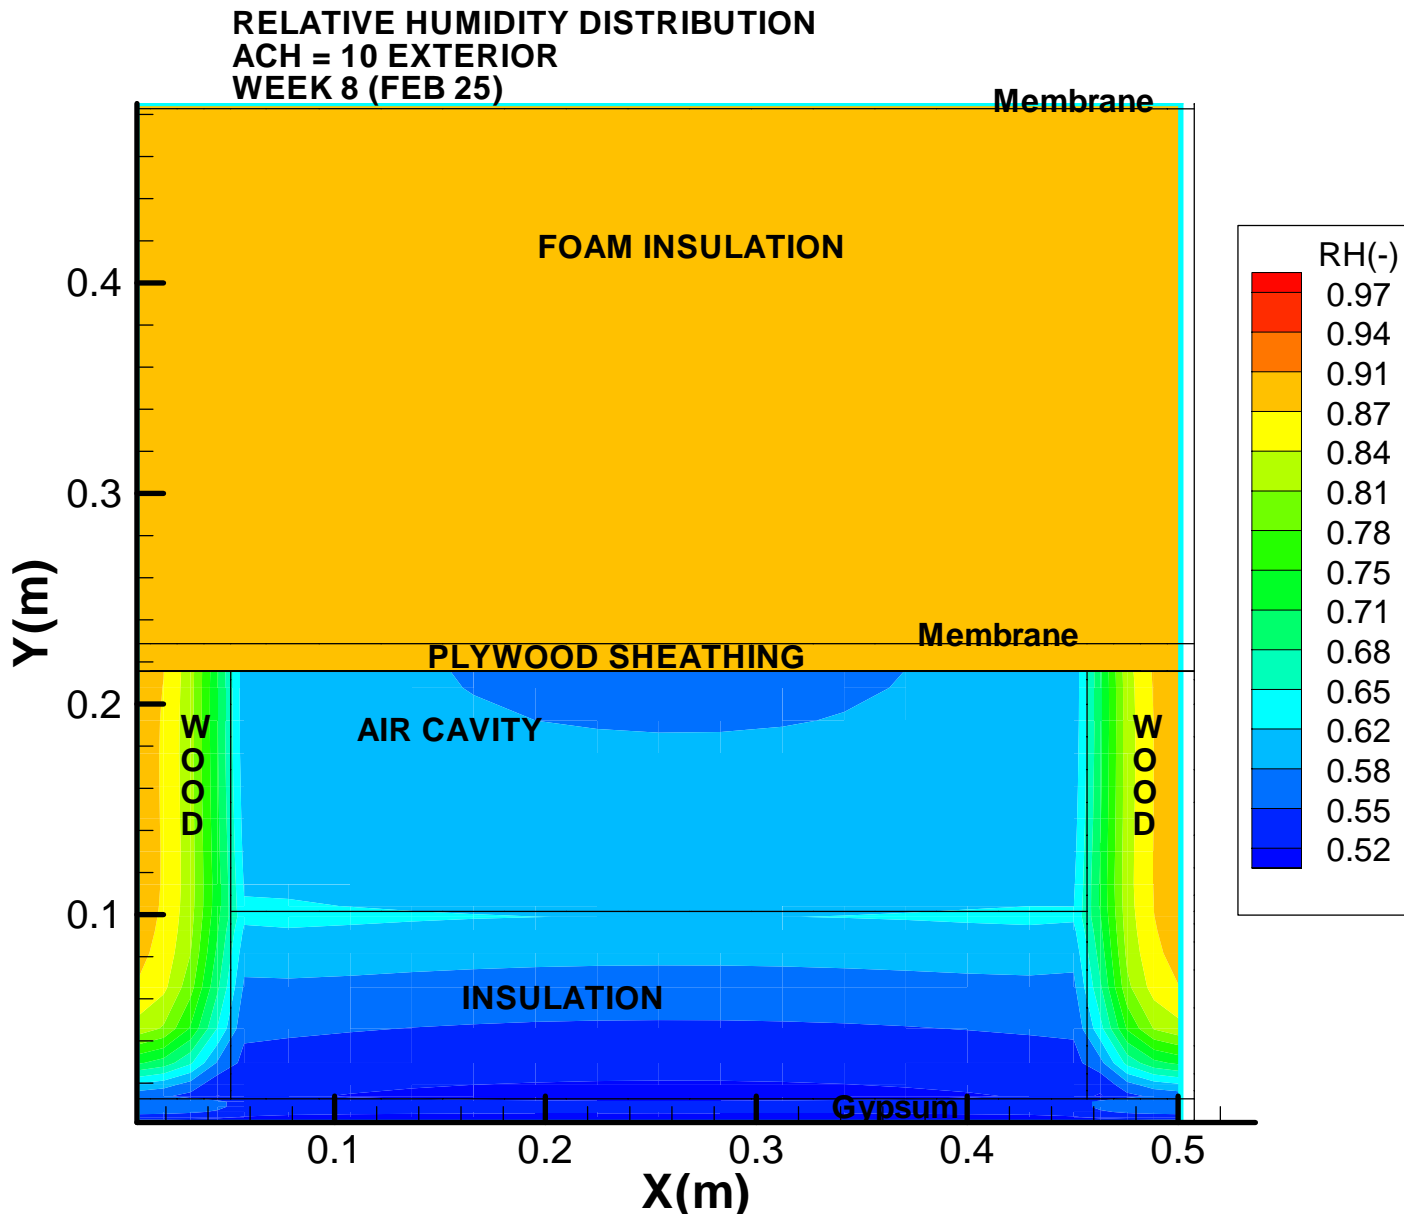
Figure 22: Retrofitted Roof Relative Humidity Distribution at week 8 with ACH =10 EXTERIOR

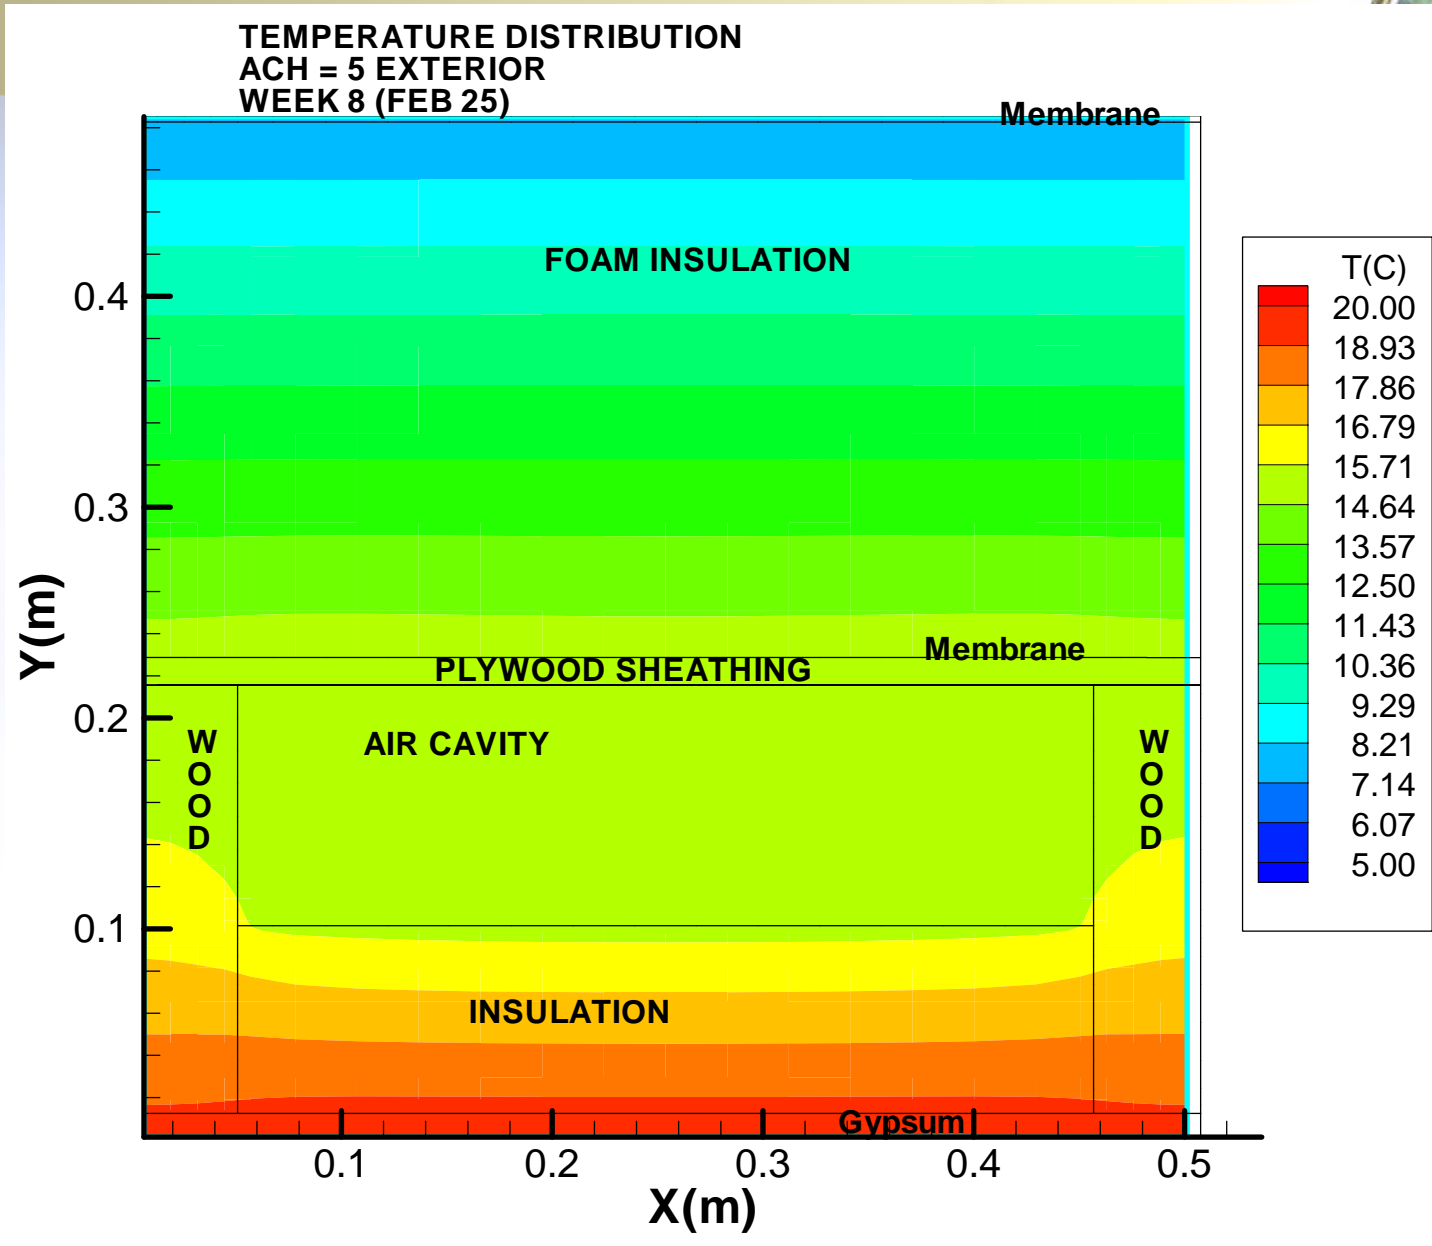
Figure 28 Retrofitted Roof Temperature Distribution week 8 at ACH=5 from the EXTERIOR

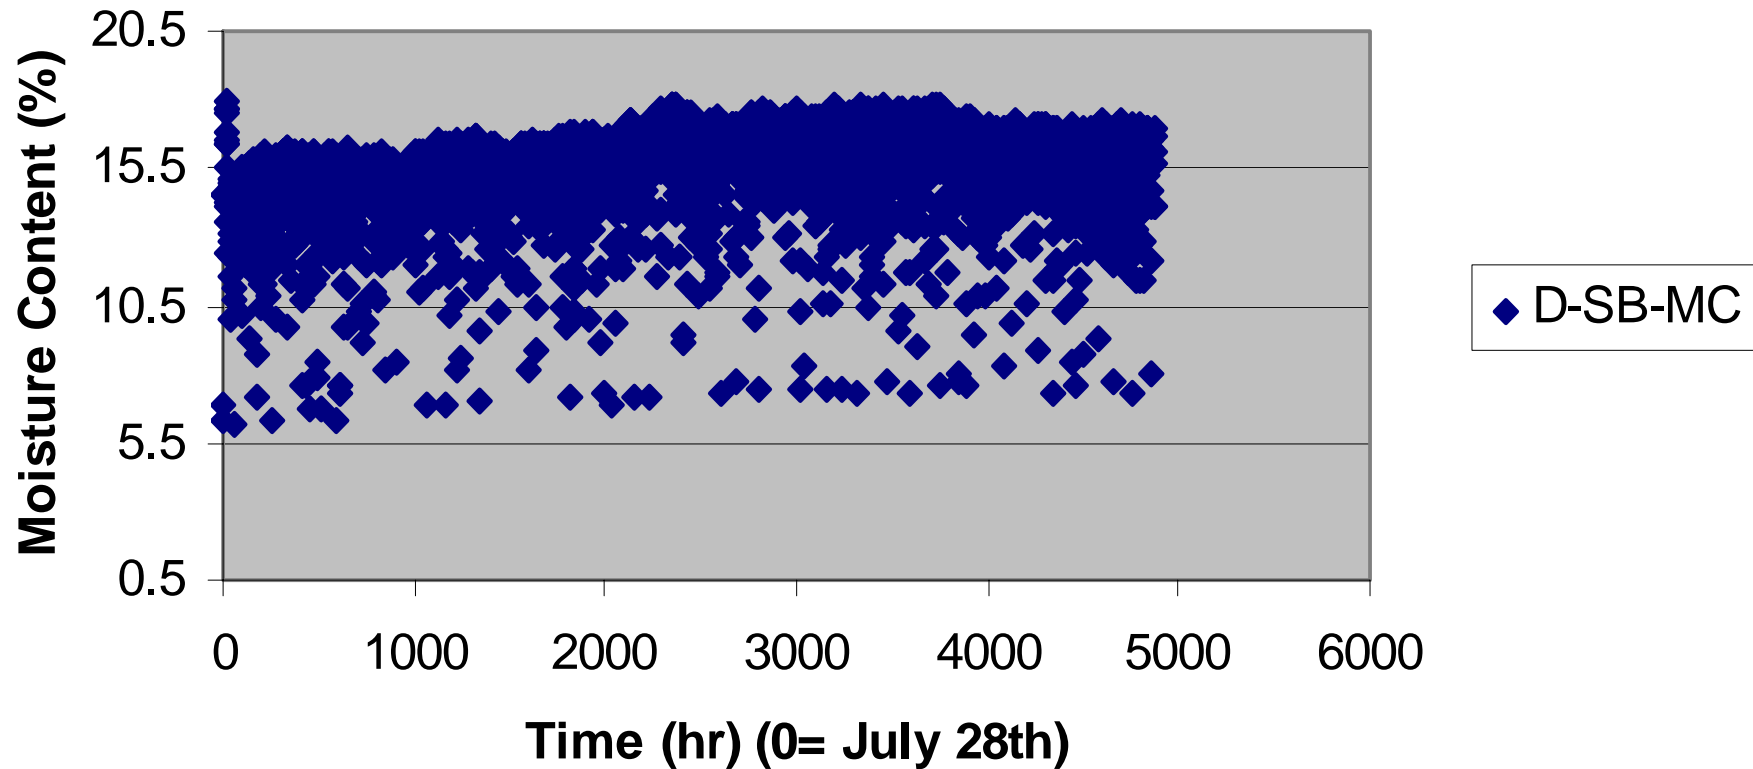
D-SB-MC

Measured Retrofit MC Distribution (Sheathing)

The retrofit ROOF resulted in DRY wood conditions

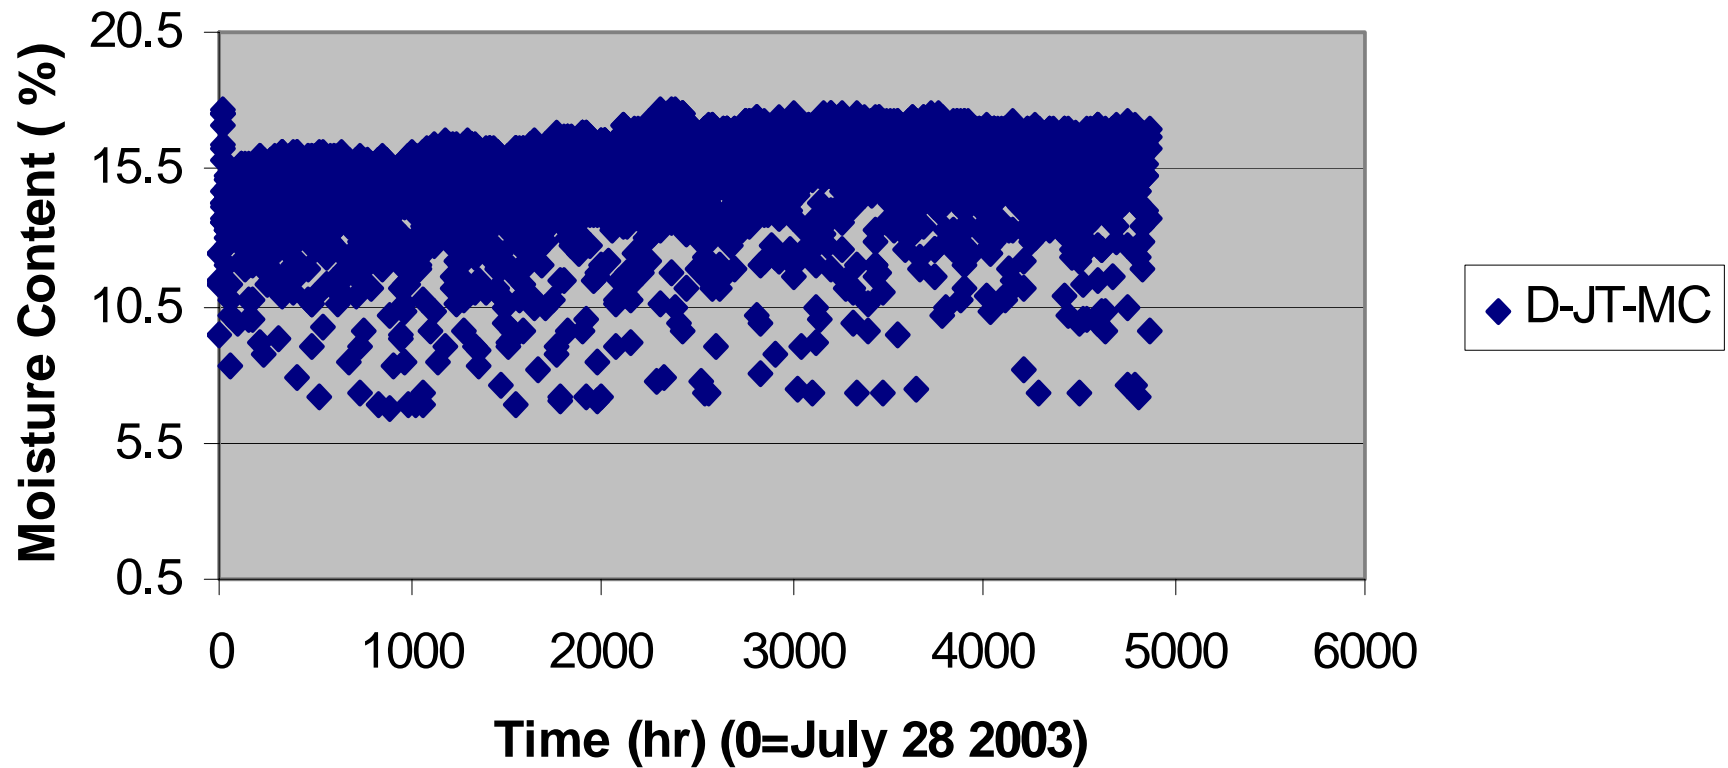
D-JT-MC

Measured Retrofit MC Distribution (Top Joist)

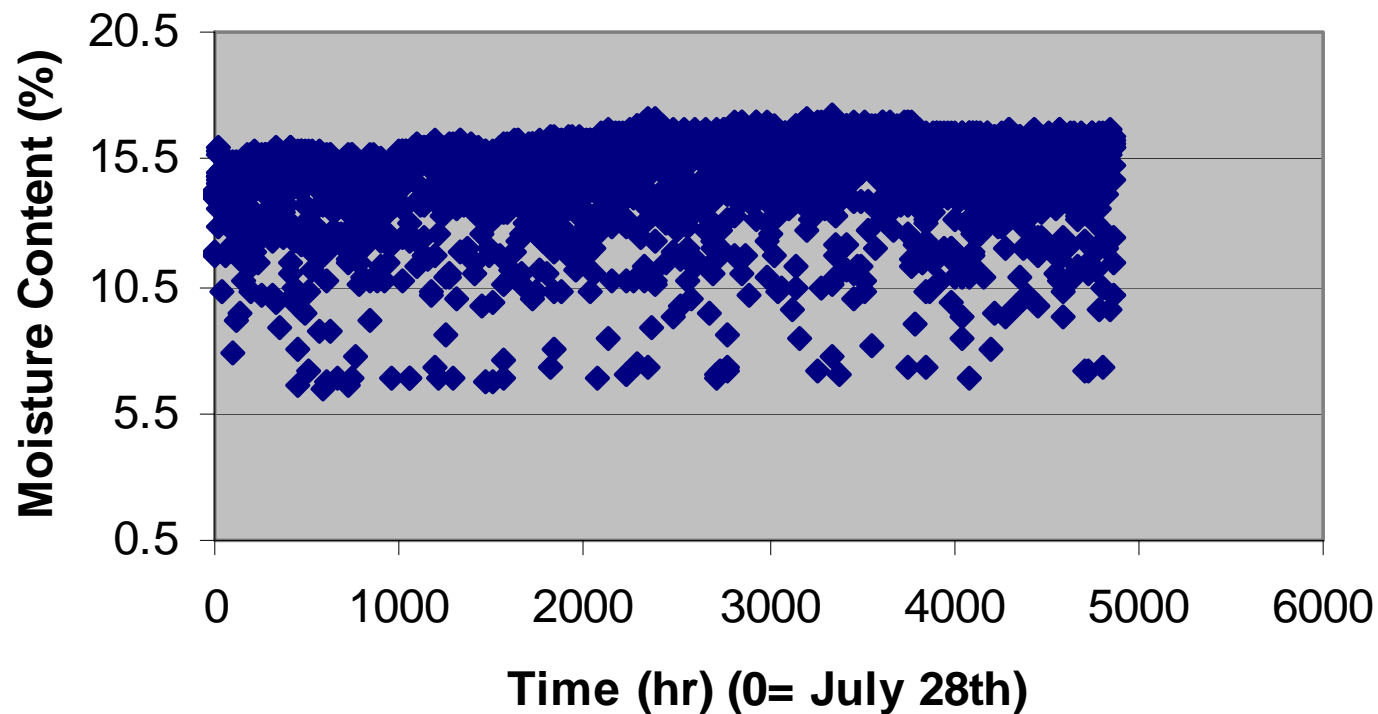
D-JB-MC

Measured Retrofit MC Distribution (Top Joist)
