Teton Dam Failure Case Study

Summarized from Solava and Delatte, *Lessons from the Failure of the Teton Dam*, Proceedings of the 3rd ASCE Forensics Congress, October 19 - 21, 2003, San Diego, California

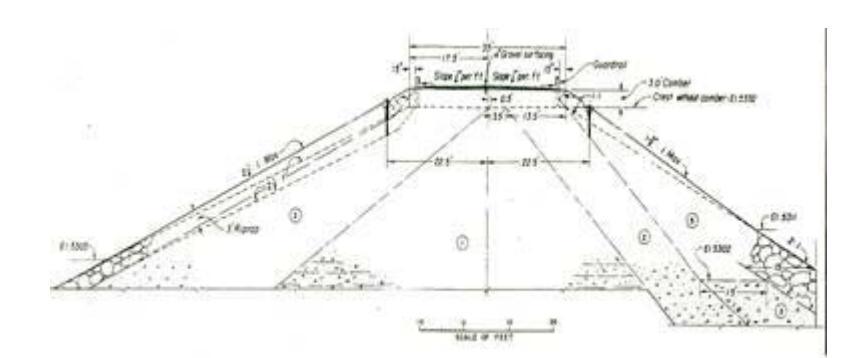
Figure 1b. Dam Construction Details - Cross Section (from Independent, 1976)

The embankment itself consisted of five main zones. Zone 1 was the impervious center core, which formed the water barrier of the dam. Zone 2 overlaid Zone 1 and extended downstream to provide a layer to

control seepage through the foundation. Zone 3 was downstream and its main function was to provide structural stability. Zone 4 consisted of the storage areas downstream from the control structure and the temporary enclosures built to permit the work to be done. Finally, Zone 5 was the rockfill in the outer parts of the embankment (Independent Panel, 1976). Some of these features are shown in Figure 1.

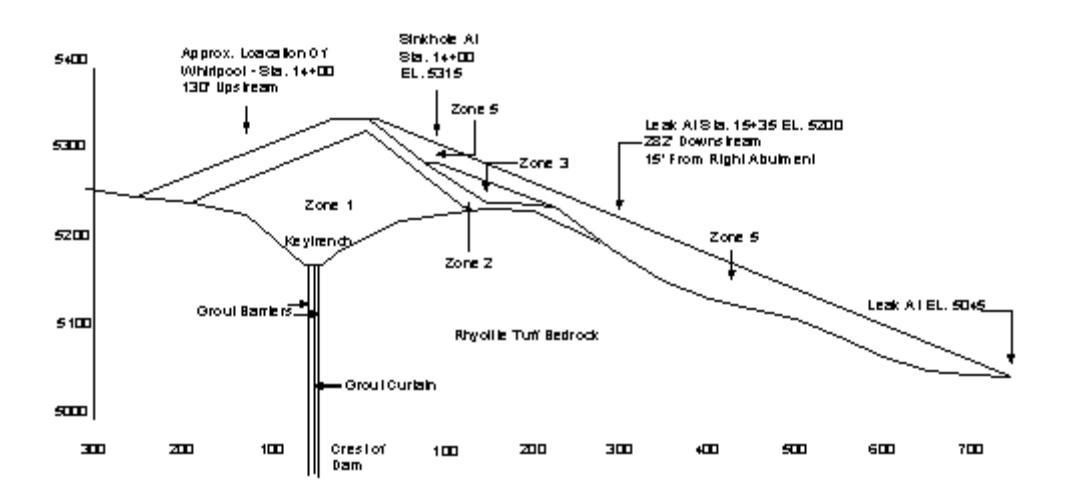
Figure 2. Initial failure indications (from Independent Panel, 1976)

On June 5, 1976 the first major leak was noticed between 7:30 and 8:00 a.m. The leak was flowing at about 500 to 800 liters per second (20 to 30 cfs) from rock in the right abutment. By 9:00 a.m. the flow had increased to 1,100 to 1,400 liters per second (40 to 50 cfs) and seepage had been observed about 40 meters (130 feet) below the crest of the dam (Arthur, 1977).

At 11:00 a.m. a whirlpool was observed in the reservoir directly upstream from the dam and four bulldozers were sent to try to push riprap into the sinkhole near the dam crest (Independent Panel, 1976). Two of the bulldozers were swallowed up by the rapidly expanding hole, and the operators were pulled to safety by ropes tied around their waists (Teton Dam Flood @ 2002). Figure 2 shows a cross section of the dam with the approximate locations of the seepage, the sinkhole, and a whirlpool in the reservoir noted.
