# ROOFS, SNOW AND ICE DAMS

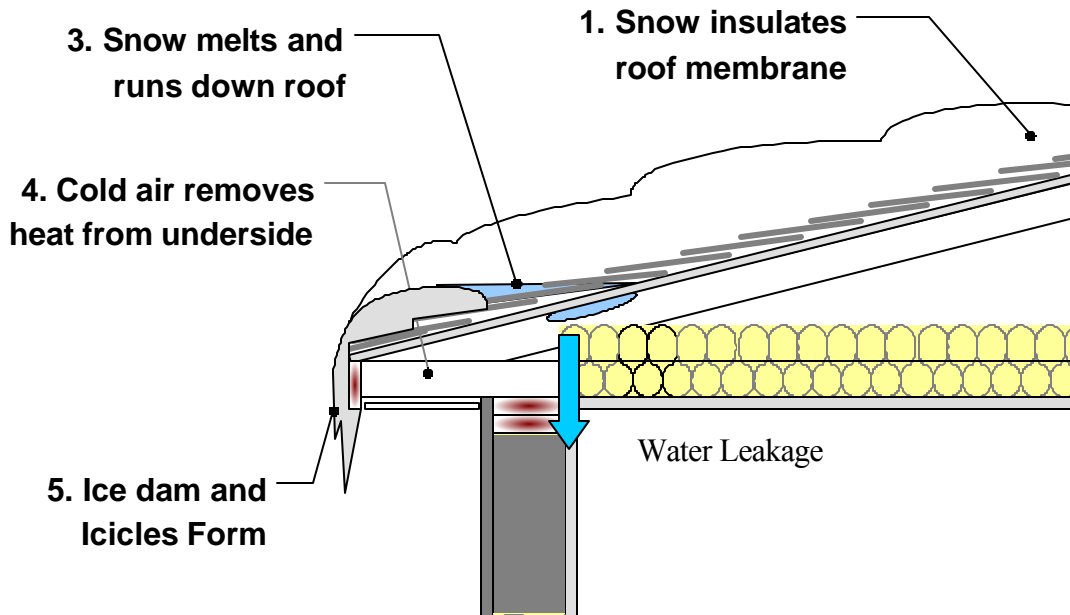
Ice dams are a common roof performance problem in cold climate buildings. Simply put, they are ridges of ice and icicles caused by melt water from further up the roof re-freezing lower on the roof. The “dam” created by the ridge of ice along the eaves can trap further meltwater and result in significant leakage under and through the roofing, especially shingles and metal roofing. This leakage can cause damage to the sheathing, the roof structure, or the ceiling and walls below. Large icicles along the eaves can become a danger to people below if they fall.

Figure 1: Ice Dam at a Typical Roof

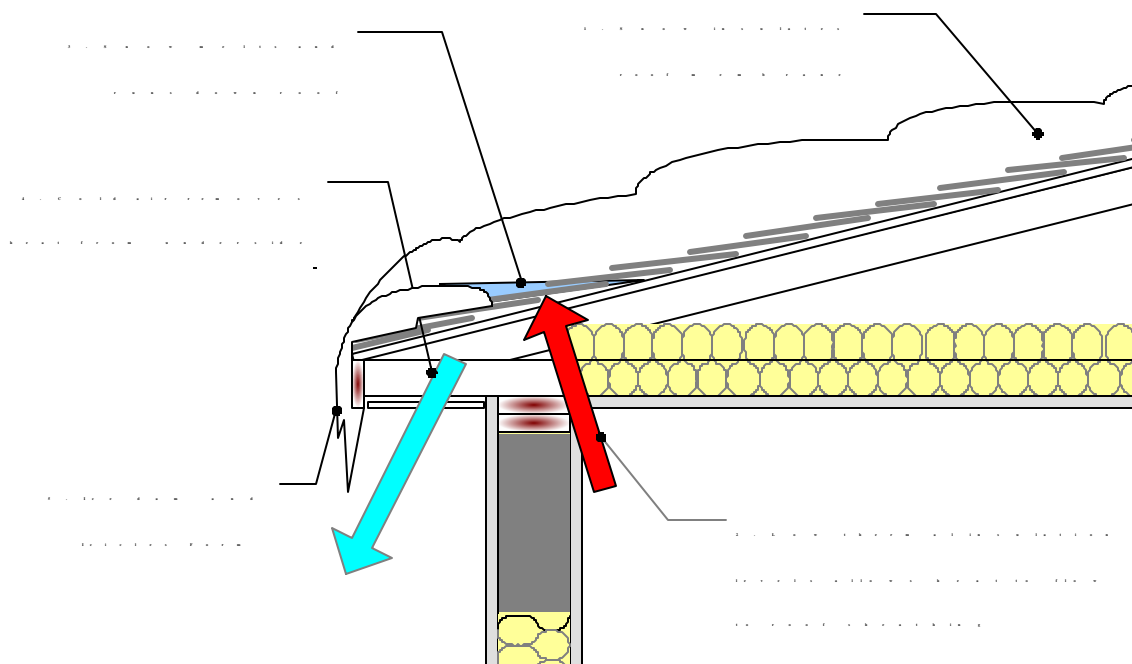
If there is insufficient insulation between heated space and the roof sheathing, significant amounts of heat can flow to the underside of the sheathing. Snow also insulates the roof membrane, increasing its temperature. This scenario will raise the temperature of the roof-snow interface above the melting point even at cold outdoor temperatures. The result is many hours of snow melting with sufficiently low temperatures to ensure rapid freezing (Fig 2).

**Figure 2: The Process of Ice Dam Formation Caused by Poor Insulation**

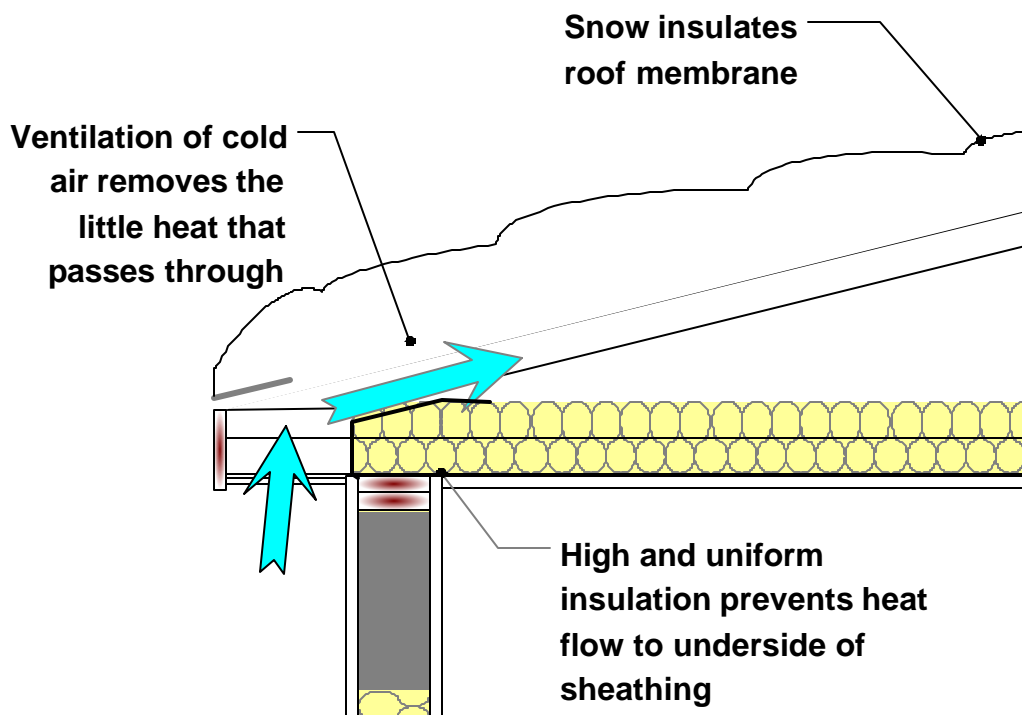
Another way to keep the sheathing cold is to ventilate with outdoor air (Fig 3). Although ventilation will remove some of the heat that passes through the ceiling, very low levels of insulation and thermal bridging cannot practically be offset by ventilation. Ventilation is best used as a supplement to good insulation – ventilation can be used to remove the little heat that flows through a well insulated roof.

**Figure 3: Solutions to Poor Insulation**

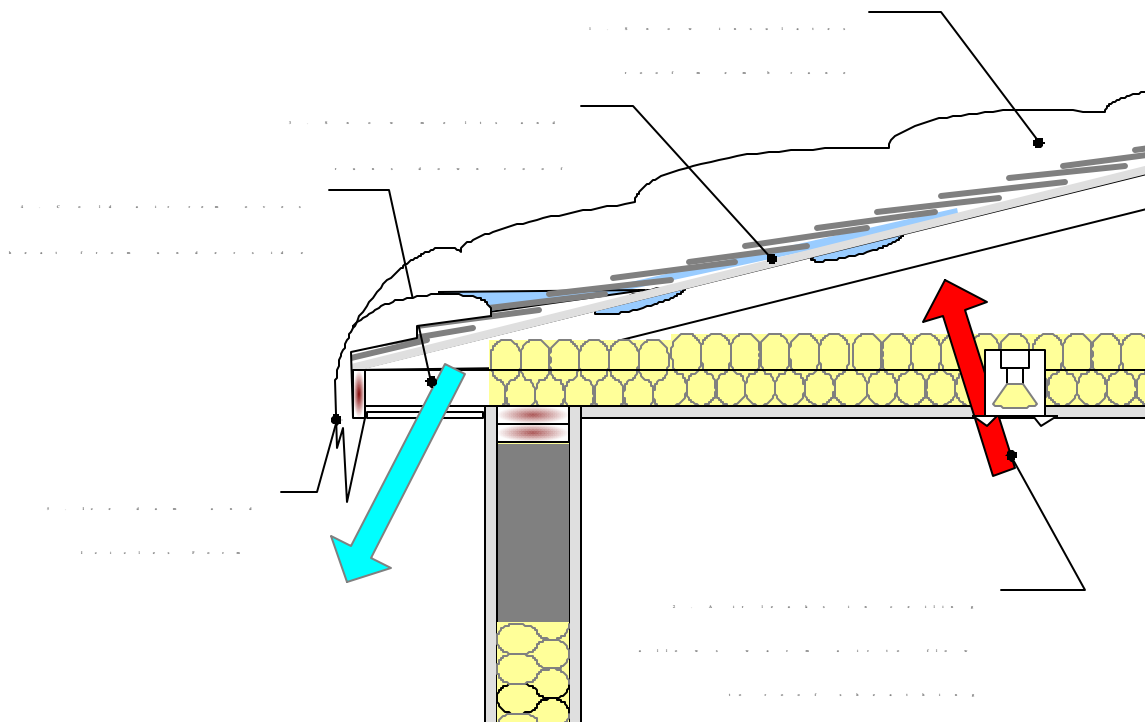
Not only does air leakage into the roof cause warming and melting of snow, in colder weather it often causes condensation on the underside of the roof sheathing. The two processes combined can cause serious wetting and decay of the sheathing and roof structure as well as leakage into the space below (Fig 4).

**Figure 4: Ice Dam Formation Process Caused By Air Leakage**

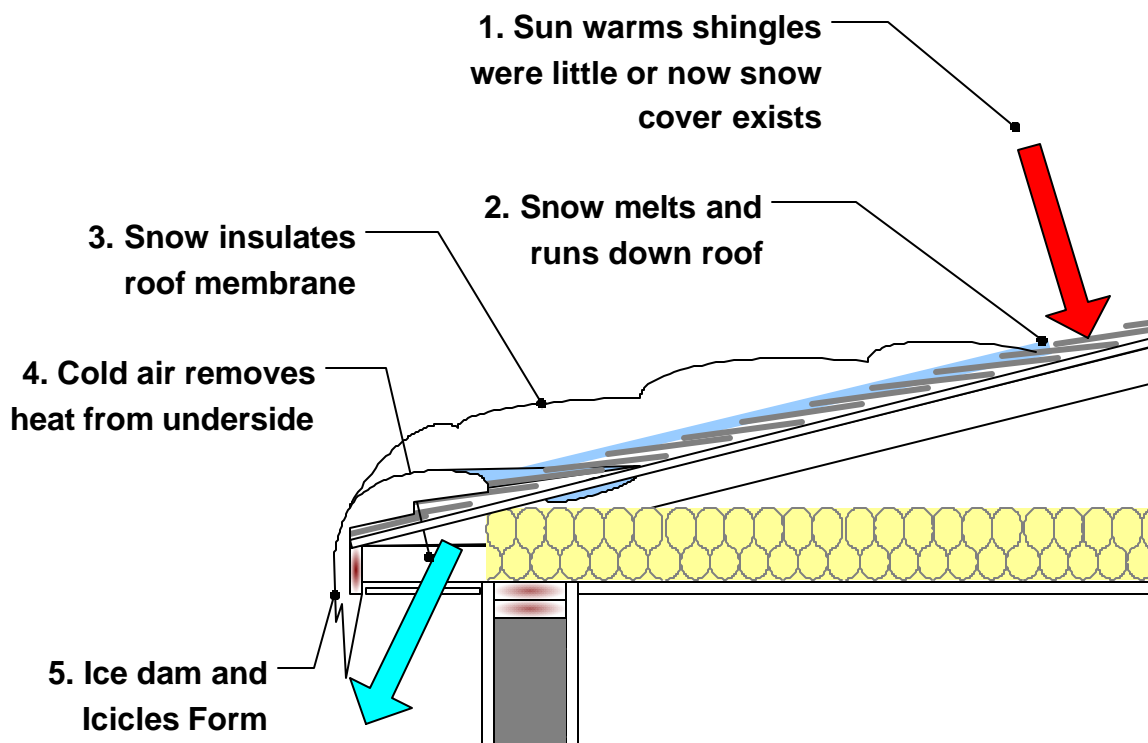
Wind speeds are often higher near ridge lines and scour snow from the roof. Snow catchers at the base of metal roofs hold back sliding snow near the eaves. Exposed shingles or metal can easily be heated to 70 F (40 C) above ambient air temperature and cause melting of the snow immediately next to the exposed roofing. Water will run down the roof and can freeze at the eave, which is cooled from the underside (Fig 5). If the temperature is cold enough and the snowcover thin enough the melt water may form a relatively harmless thin sheet of ice below the snow. In other situations, large ice dams and icicles can form.

**Figure 4: Ice Dam Formation Process Due to Uneven Snow Thickness**

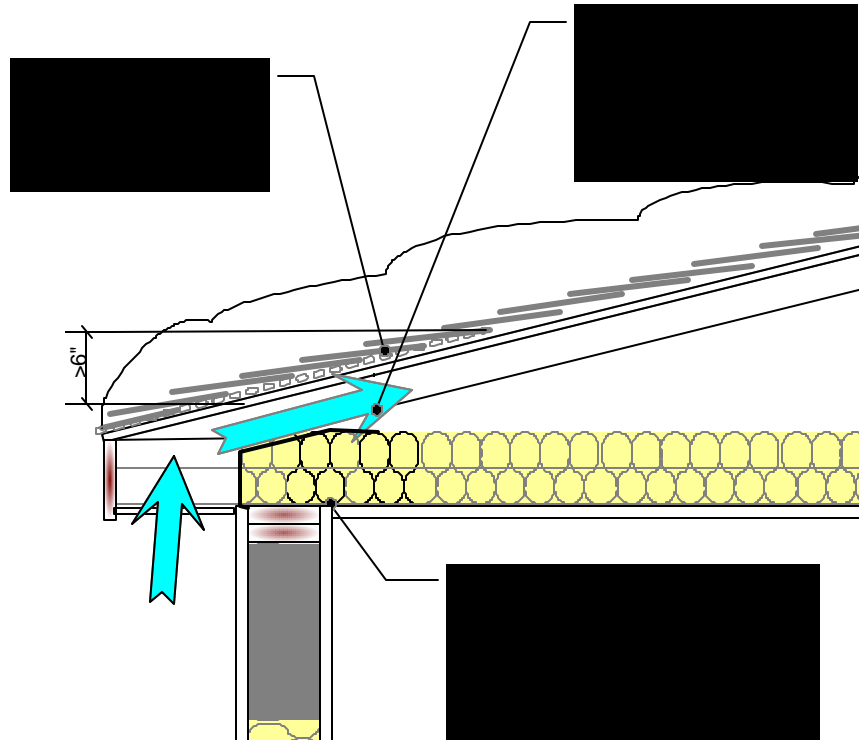
Even if all good design practises are followed this process can still occur. For this reason it is recommended that a waterproof membrane (preferably self-sealing to accommodate roofing nails) be provided. This membrane should come up the roof high enough to resist a 6 to 8" height of water above the edge of the wall insulation below (Fig 6). Hence, steep pitched roofs will require a narrower strips of this membrane than shallow roofs.

**Figure 6: Waterproof “eaves-starter” or “Ice and Water Shield”**

Finally, since the sun can cause some melting on exposed upper portions of a roof, one typically needs to provide a layer of self-sealing waterproofing at the eaves of all sloped roofs. This provides some back-up protection in the event that other strategies are not perfectly implemented.
