## Wood Pitched Roof Construction

### Introduction

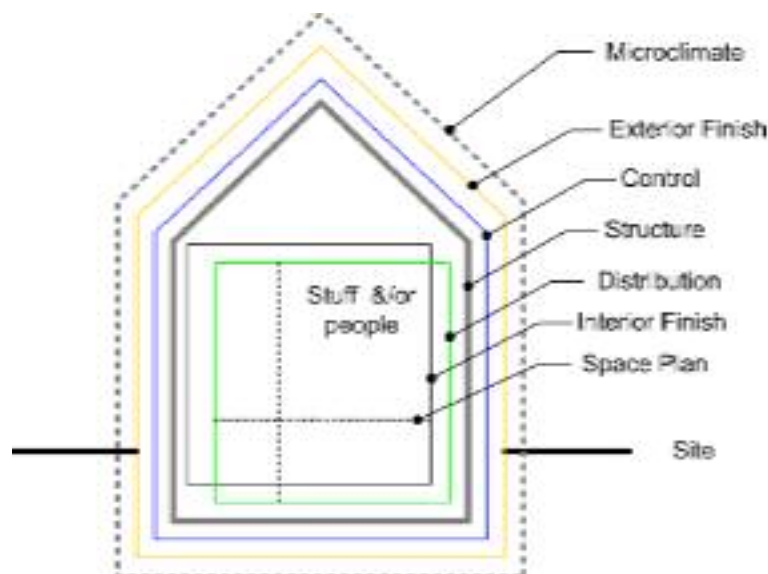
**Figure 1: Building and Enclosure Functions**

Roofs must fulfill the same basic functions as all building enclosure elements. These functions can be categorized as: support, control, and finish and sometimes the distribution of services (a building function) is imposed on the enclosure. The distribution of plumbing stacks and forced air conditioning systems within the roof enclosure can have a profound impact on behavior.

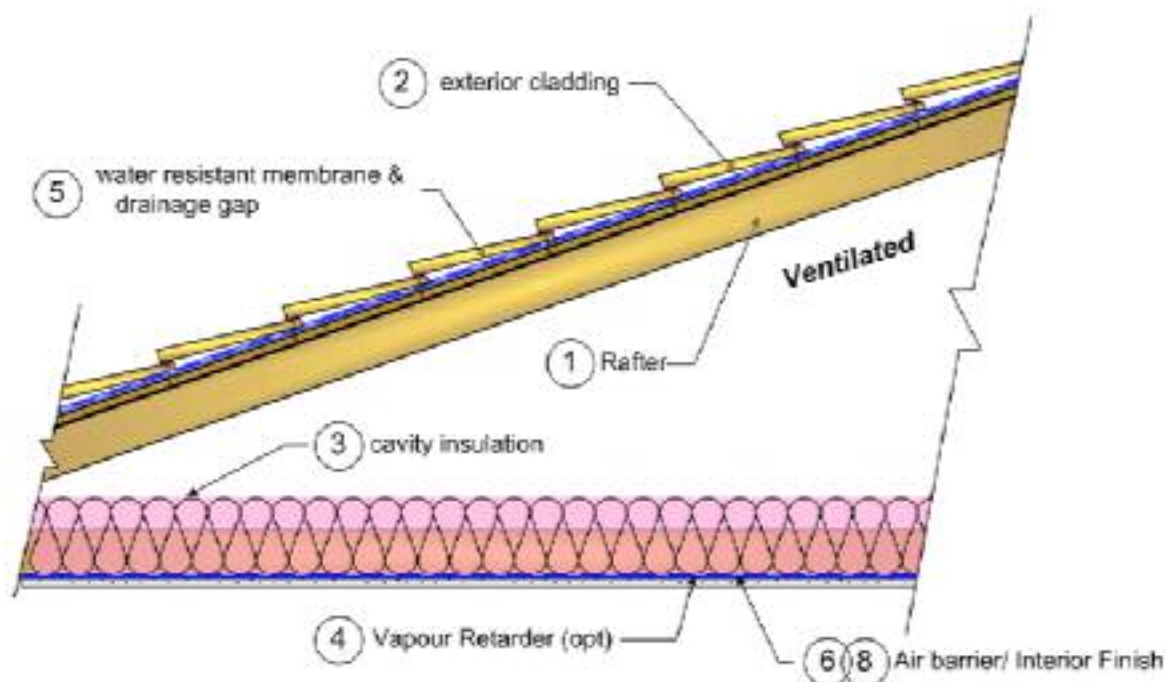
| <p>① Wood framed rafter and joist (shown)<br/>or wood truss<br/>Steel framed rafter and joist or truss</p> <p>② Cedar shakes (shown)<br/>Metal panels, standing seam<br/>Asphalt Shingles<br/>Exposed Membranes</p> <p>③ Batt (shown)<br/>Blown-in cellulose fiberglass, rockwool<br/>Spray Foam</p> <p>④ Optional<br/>Paint or vinyl wallpaper on drywall<br/>Polyethylene<br/>foil-backed drywall<br/>Kraft facing on batt</p> | <p>⑤ Asphalt impregnated felt<br/>Asphalt impregnated building paper<br/>Permeable polymer "housewrap"<br/>Impermeable self-sealing membrane</p> <p>⑥ Drywall (shown)<br/>Spray-foam on substrate<br/>membrane (supported)</p> <p>⑧ Painted drywall<br/>Wood paneling<br/>Vinyl wallpaper on drywall<br/>Textured coating</p> |

Figure 3: Typical Pitched and Ventilated Attic

Consider the typical wood frame attic shown below in Figure 3. This is the most common type of wood roof, with a pitched water-shedding surface, a horizontal ceiling plane which supports insulation, separated by an attic space ventilated with outdoor air. Common materials/systems for functions 1 through 8 are listed on this drawing.

The choices for support function (1) are provided either by a rafter systems (essentially a structural beam with bracing provided by joists, collar ties, parallel walls or a combination) or a truss system (which produces no outward thrusts and is a self-contained element). The exterior screen and finish (2) are typically composition shingles, wood shakes, metal panels, or concrete or clay tiles. The interior finish (8) is almost always one of painted drywall, textured coating on drywall, vinyl wall paper or wood paneling.

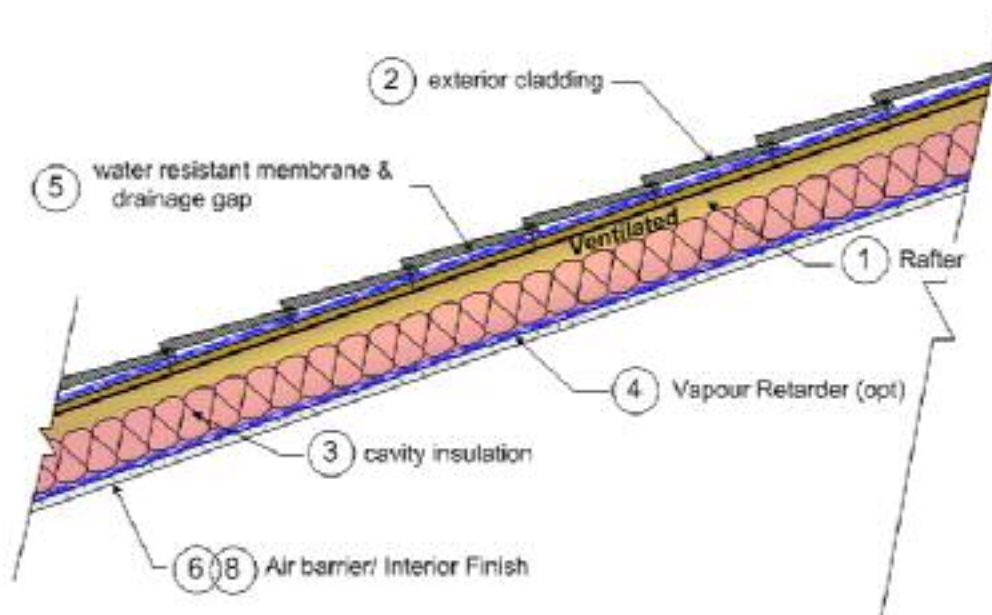
| <p>① Wood framed rafter and joist (shown)<br/>or wood truss<br/>Steel framed rafter and joist or truss</p> <p>② Cedar shakes (shown)<br/>Metal panels, standing seam<br/>Asphalt Shingles<br/>Exposed Membranes</p> <p>③ Batt (shown)<br/>Blown-in cellulose fiberglass, rockwool<br/>Spray Foam</p> <p>④ Optional<br/>Paint or vinyl wallpaper on drywall<br/>Polyethylene<br/>foil-backed drywall<br/>Kraft facing on batt</p> | <p>⑤ Asphalt impregnated felt<br/>Asphalt impregnated building paper<br/>Permeable polymer "housewrap"<br/>Impermeable self-sealing membrane</p> <p>⑥ Drywall (shown)<br/>Spray-foam on substrate<br/>membrane (supported)</p> <p>⑧ Painted drywall (shown)<br/>Wood paneling<br/>Vinyl wallpaper on drywall<br/>Textured coating</p> |

Figure 4: Typical Pitched and Ventilated Cathedral Ceiling

Figure 4 describes the most common assembly geometry that results in a cathedral ceiling. In this case a ventilation space is kept above the insulation to provide a path for ventilation airflow between the ridge and soffit. This system often experiences performance problems in cold weather since the rate of ventilation is often quite small (due to the friction with the sides of the small space, the length of the run, the high probability of a misplaced batt insulation blocking flow, and the many areas on roofs that do allow direct connections between the ridge and soffit). If air can leak outward during cold weather (i.e., an air barrier is not provided, or it is breached a light fixtures, interior partition walls, etc) the ventilation gap provides an easy means of exiting the roof system. In this scenario, the ventilation of the roof encourage the outward flow of indoor air and encourages significant amount of condensation that cannot easily be subsequently dried.

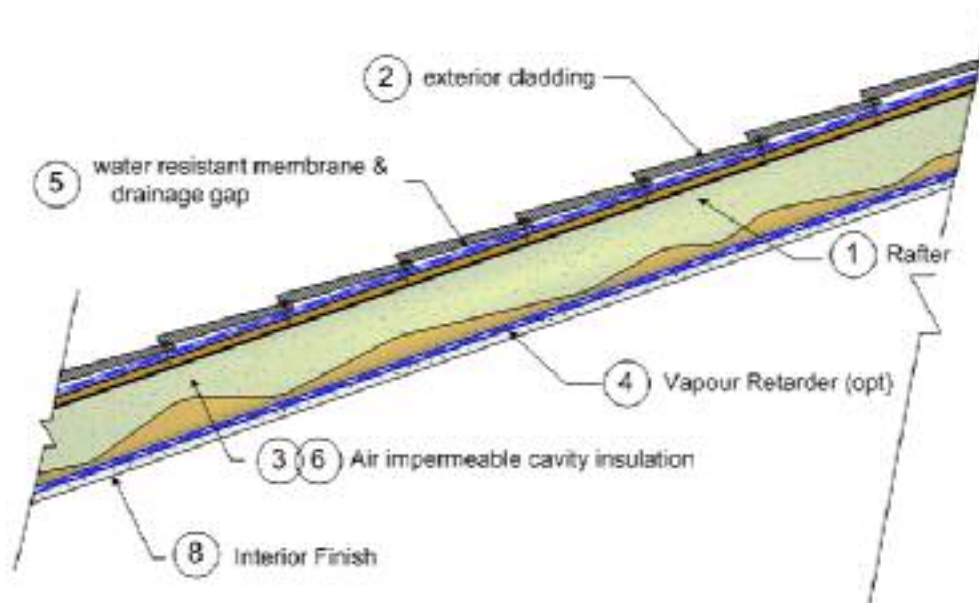
| <p>① Wood framed rafter and joist (shown)<br/>or wood truss<br/>Steel framed rafter and joist or truss</p> <p>② Cedar shakes (shown)<br/>Metal panels, standing seam<br/>Asphalt Shingles<br/>Exposed Membranes</p> <p>③ Dens-pack cellulose w/good air barrier<br/>Spray Foam (shown)</p> <p>④ Optional<br/>Paint or vinyl wallpaper on drywall<br/>Polyethylene<br/>foil-backed drywall<br/>Kraft facing on batt</p> | <p>⑤ Asphalt impregnated felt<br/>Asphalt impregnated building paper<br/>Permeable polymer "housewrap"<br/>Impermeable self-sealing membrane</p> <p>⑥ Drywall<br/>Spray-foam on substrate (shown)<br/>membrane (supported)</p> <p>⑧ Painted drywall (shown)<br/>Wood paneling<br/>Vinyl wallpaper on drywall<br/>Textured coating</p> |

Figure 5: Typical Pitched and Unvented Cathedral Ceiling

Unvented cathedral ceilings (Figure 5) were developed to deal with some of the problems. However, this system relies on excellent airflow control, both the avoidance of convective loops and through roof air leakage. The drying potential of this system is lower than most as it relies exclusively on diffusion to remove moisture. Such roofs can, and have for many years, work well. However, the airflow control and inward vapor drive issues must be dealt with. Although an air barrier system made of drywall can in theory meet the requirements, practice has shown that most builders cannot provide sufficiently airtight ceilings. Given this reality, such roofs are usually recommended with air impermeable spray foam insulation that controls through flow and convective loops. Dense cellulose can also meet this requirement if the airtightness of the ceiling air barrier plan is almost perfect and interior humidity and air pressures are kept in check.

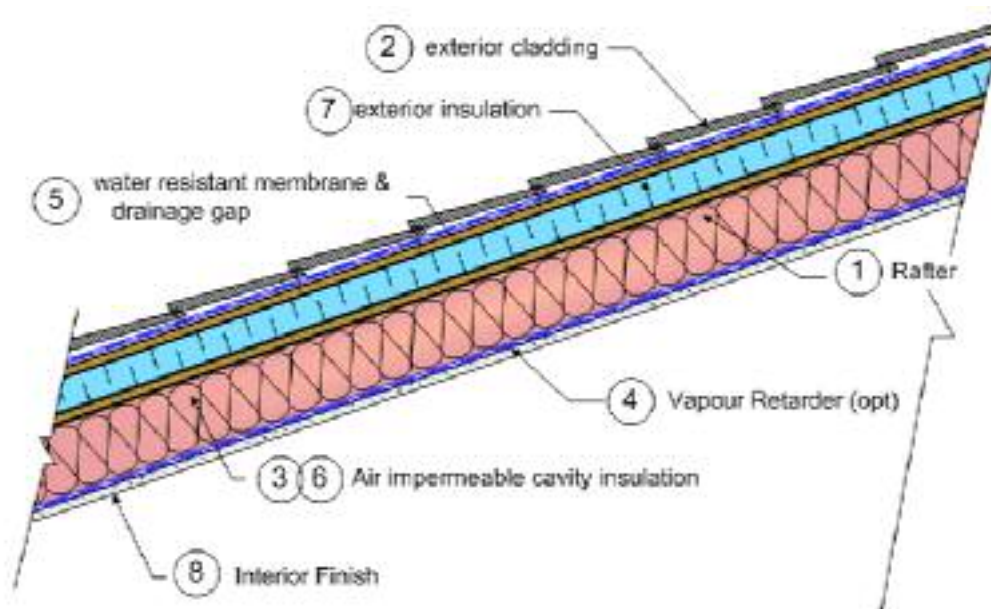
| <p>① Wood framed rafter and joist (shown)<br/>or wood truss<br/>Steel framed rafter and joist or truss</p> <p>② Cedar shakes (shown)<br/>Metal panels, standing seam<br/>Asphalt Shingles<br/>Exposed Membranes</p> <p>③ Dens-pack cellulose w/good air barrier<br/>Spray Foam (shown)</p> <p>④ Optional<br/>Paint or vinyl wallpaper on drywall<br/>Polyethylene<br/>foil-backed drywall<br/>Kraft facing on batt</p> | <p>⑤ Asphalt impregnated felt<br/>Asphalt impregnated building paper<br/>Permeable polymer "housewrap"<br/>Impermeable self-sealing membrane</p> <p>⑥ Drywall<br/>Spray-foam on substrate (shown)<br/>membrane (supported)</p> <p>⑦ Expanded Polystyrene<br/>Extruded Polystyrene<br/>Wood Fibre Board Products</p> <p>⑧ Painted drywall (shown)<br/>Wood panelling<br/>Vinyl wallpaper on drywall<br/>Textured coating</p> |

Figure 6: Typical Pitched and Unvented Cathedral Ceiling

Locating a continuous air impermeable insulation layer on the exterior of the roof in Figure 5 results in an assembly such as Figure 6. The application of the insulation brings the temperature of the sheathing on the rafters closer to the interior temperature. This reduces or eliminates the likelihood and severity of condensation due outward air leakage and the foam controls inward vapor diffusion from moisture storing roof materials.

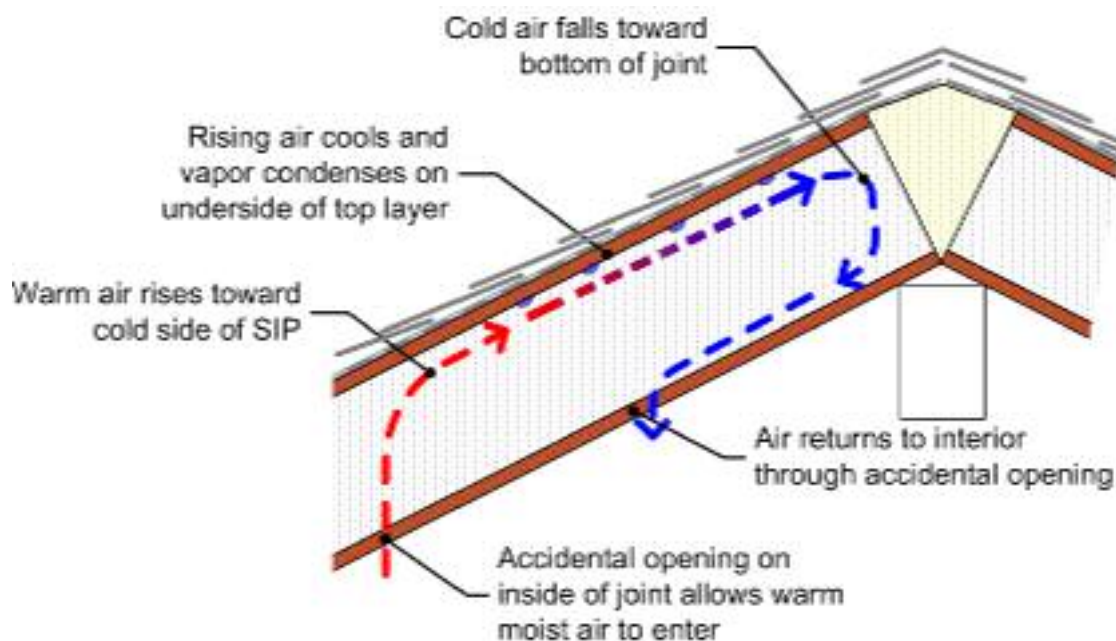
**Figure 8: Convective loop condensation processes in roofs (in this case joint in SIPs)**

In some cases, air leakage from interior, through the roof assembly, and back into the building, can result in the same type of condensation damage (Figure 8) as through-roof air leakage.

Both types of air leakage condensation damage will be worse when the exterior temperature is low (almost always at night when the sun provides little solar heating to the roof), the interior humidity is high, and the interior air pressure is higher than exterior (caused by a combination of wind forces, thermal buoyancy, and mechanical equipment pressurization).
